LOOKING BACK AT FLOODING

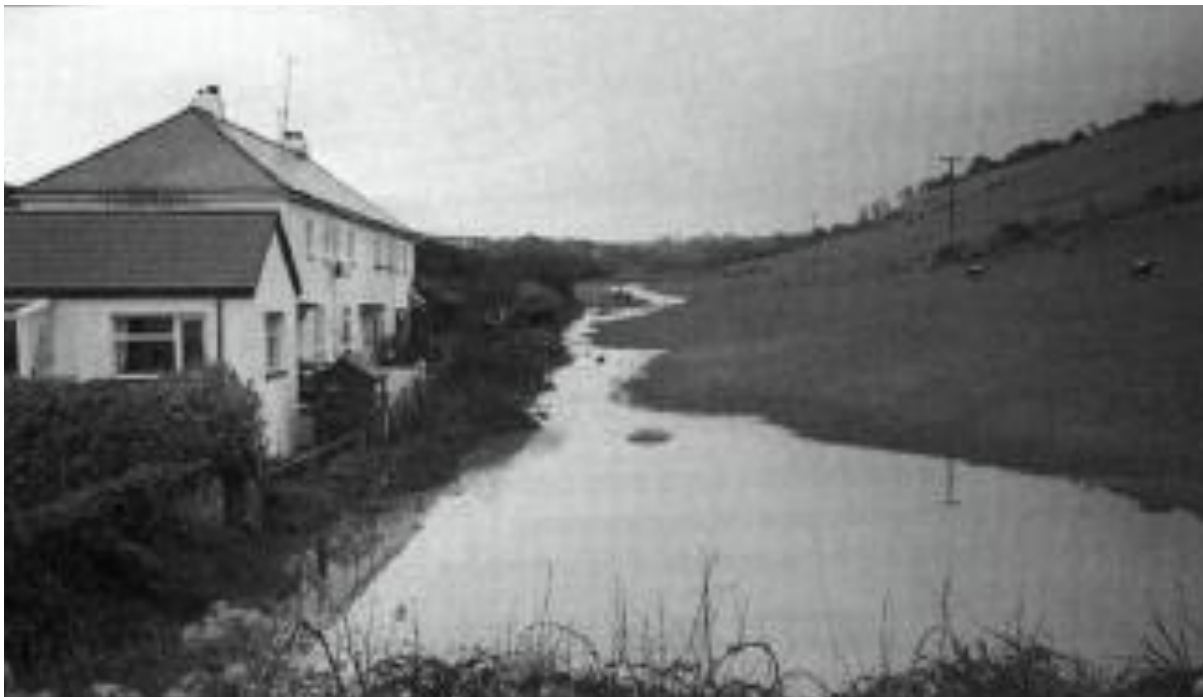
Meadow View Terrace looking upstream from New Road, Outer Hope. This photograph was taken several hours after the height of the flooding and while flood water was draining away. At the peak of the incident, flood water lapped at the back doors of the Terrace from the deep lake of flood water pictured above. The manmade leat is on the opposite side of the terrace about 6 feet higher. Flood water is clearly visible running down the valley following the old course of the diverted stream.

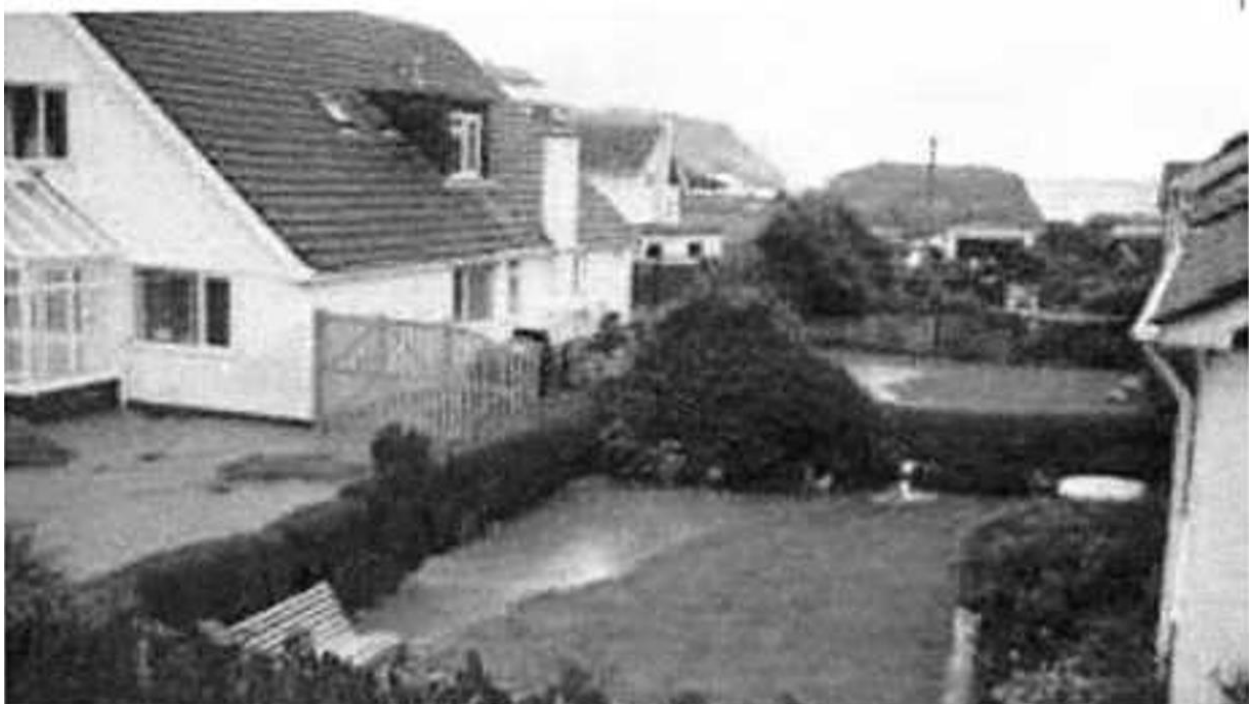
This is a typical example of minor flooding caused by rain water reverting to the course of the old stream when the leat becomes overwhelmed. This can occur quickly and disappears in a few hours without causing significant damage. Walls, fencing and garden landscaping haven't helped and now the course of the old stream has almost disappeared – that's until it floods.
